Causes of cracks in plasterboard joints

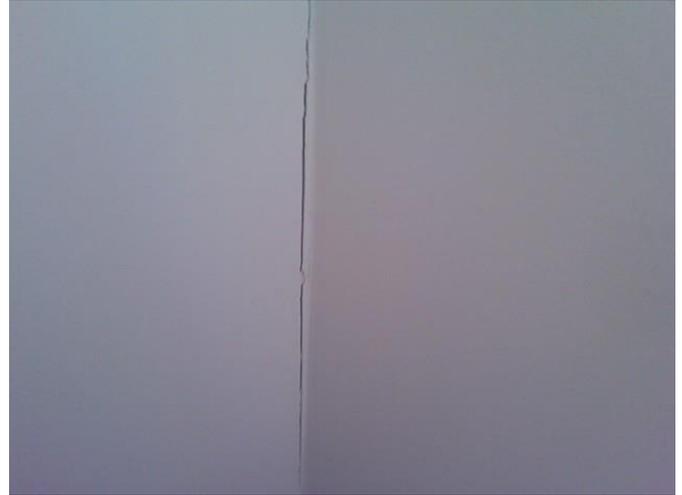
Poor installation can lead to cracking particularly where the short edges of the board is jointed at a double lift, here the common mistake is to omit installing flat plate. Not only does this allow boards to move but would invalidate any performance warranty from a systems supplier. Likewise, Incorrect centring and fixing of the drywall screws can lead to movement at the plasterboard edges.
