Transition trims

When we are required to investigate the causes of ceiling collapses and tiles falling, the construction of the suspended ceiling is often the primary issue, however a contributing factor can be the construction of the plasterboard margins, and in particular the transition between the two elements. Here FIS independent Advisor Alex Double highlights the top ten issues that he has encountered during his visits.

Technical note

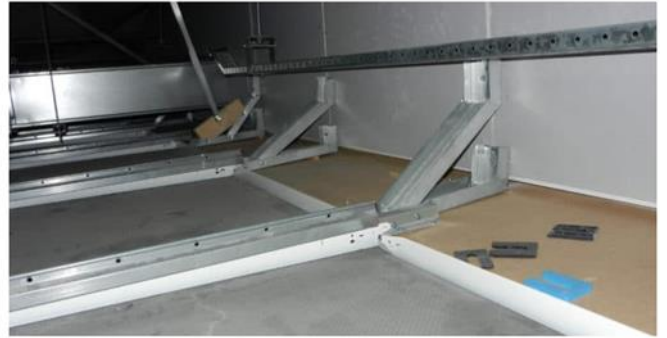
Transition trims are used at the interface of the suspended ceiling and the plasterboard margin. These can be aluminium or steel and they should be independently supported in accordance with the manufacturers recommendations to avoid any issues of movement and potential collapse. We regularly see transition trims fixed to cantilevered plasterboard or the ceiling grid without independent support.
